Hudson River Estuary Watershed Assessment & Outreach Project

2006 Watershed Report Card for Plattekill Brook, Ulster County, NY A Hudson Basin River Watch Watershed Assessment & Outreach Project

Plattekill Creek Watershed -- Station Descriptions and Water Quality Findings

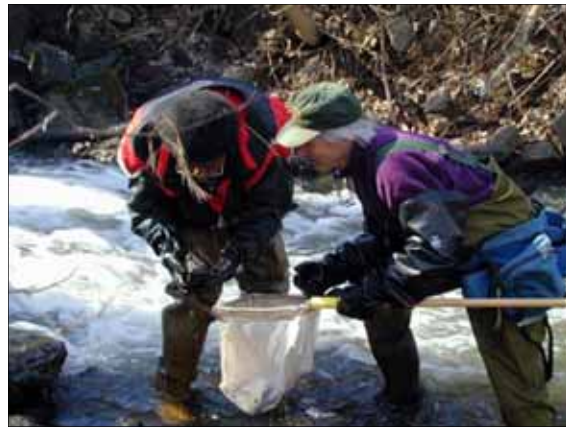
The NYS DEC Stream Biomonitoring Unit's (DEC SBU) methodology was used for all sample collection and analysis tasks. These methods involve collecting, sorting and analyzing a sample of benthic macroinvertebrates (stream bottom-dwelling organisms with no backbone that are visible to the naked eye). These organisms vary in their sensitivity to water quality impacts. DEC SBU's methods use the presence or absence, relative abundance, and diversity of species to obtain an overall water quality score called the Biological Assessment Profile (BAP). BAP is scored 0-10, with 10 indicating the best water quality. The DEC SBU also uses four narrative descriptions of water quality based on the BAP score as illustrated in this graph:

It's important to note that the term "slightly impacted" can be misleading if it's taken out of context. Sites with water quality at only 5.1 on the BAP scale, or almost "moderately impacted", can be described as only "slightly impacted".

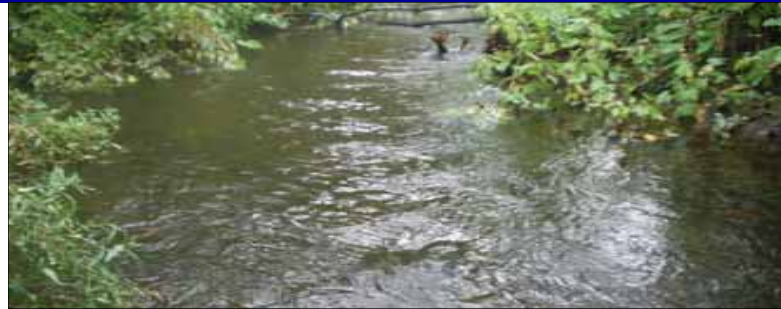
Plattekill Creek tributary Station PL03 just upstream of the Schrieber lane culvert.

Station PL03 (Tributary to Plattekill Brook), is just upstream of the Schrieber Lane culvert. The BAP score of 5.63 fell into the lower half of the slightly impacted category. The ISD indicated a community affected by nutrient additions. The Dissolved oxygen was slightly depressed, at 89% saturation.
