## Hudson River Estuary Watershed Assessment & Outreach Project

## 2006 Watershed Report Card for streams in New Paltz, New York

### A Hudson Basin River Watch Watershed Assessment & Outreach Project

## Wallkill River Watershed - New Paltz Area

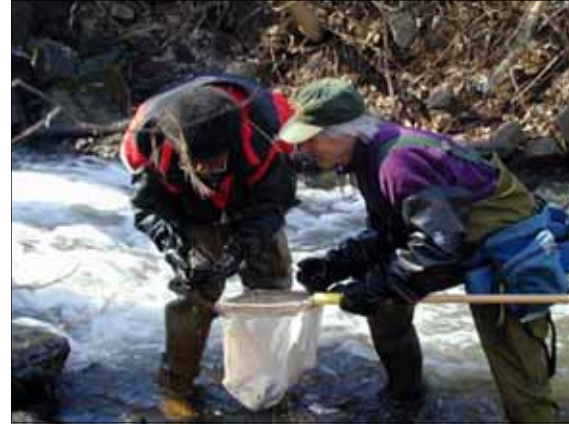
The NYS DEC Stream Biomonitoring Unit's (DEC SBU) methodology was used for all sample collection and analysis tasks. These methods involve collecting, sorting and analyzing a sample of benthic macroinvertebrates (stream bottom-dwelling organisms with no backbone that are visible to the naked eye). These organisms vary in their sensitivity to water quality impacts. DEC SBU's methods use the presence or absence, relative abundance, and diversity of species to obtain an overall water quality score called the Biological Assessment Profile (BAP). BAP is scored 0-10, with 10 indicating the best water quality. The DEC SBU also uses four narrative descriptions of water quality based on the BAP score as illustrated in this graph:

It's important to note that the term "slightly impacted" can be misleading if it's taken out of context. Sites with water quality at only 5.1 on the BAP scale, or almost "moderately impacted", can be described as only "slightly impacted".

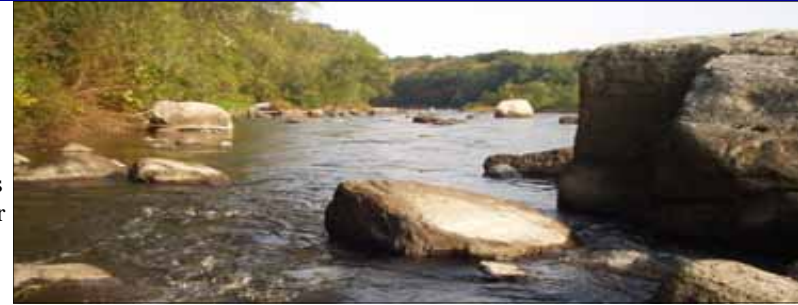
Wallkill River station NP01, "Libertyville rapids", just downstream of the fairgrounds Gardiner Ulster Co., NY

**Station NP01** (Wallkill River) is known as the "Libertyville rapids," upstream of the Ulster County fairgrounds. The Biological Assessment Profile (BAP) score, 5.65, fell in the lower half of the slightly impacted water quality category. The Impact Source Determination (ISD) indicated a community affected by non-point source nutrient additions.
