## Hudson River Estuary Watershed Assessment & Outreach Project

## 2006 Watershed Report for the Wallkill River Watershed in NY

### A Hudson Basin River Watch Watershed Assessment & Outreach Project

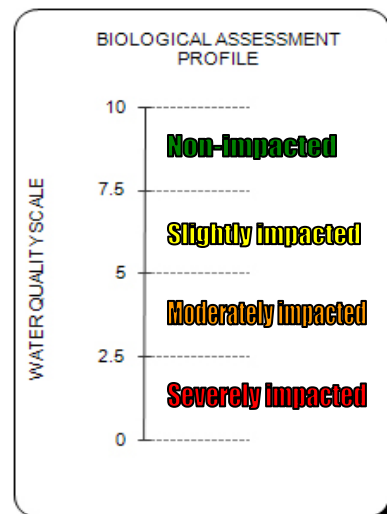
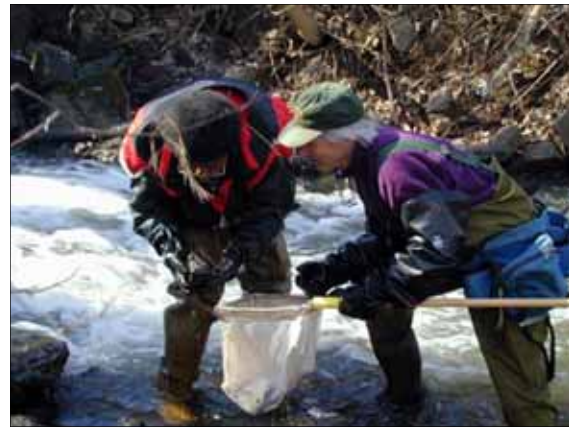
The NYS DEC Stream Biomonitoring Unit's (DEC SBU) methodology was used for all sample collection and analysis tasks. These methods involve collecting, sorting and analyzing a sample of benthic macroinvertebrates (stream bottom-dwelling organisms with no backbone that are visible to the naked eye). These organisms vary in their sensitivity to water quality impacts. DEC SBU's methods use the presence or absence, relative abundance, and diversity of species to obtain an overall water quality score called the Biological Assessment Profile (BAP). BAP is scored 0-10, with 10 indicating the best water quality. The DEC SBU also uses four narrative descriptions of water quality based on the BAP score as illustrated in this graph:

It's important to note that the term "slightly impacted" can be misleading if it's taken out of context. Sites with water quality at only 5.1 on the BAP scale, or almost "moderately impacted", can be described as only "slightly impacted".

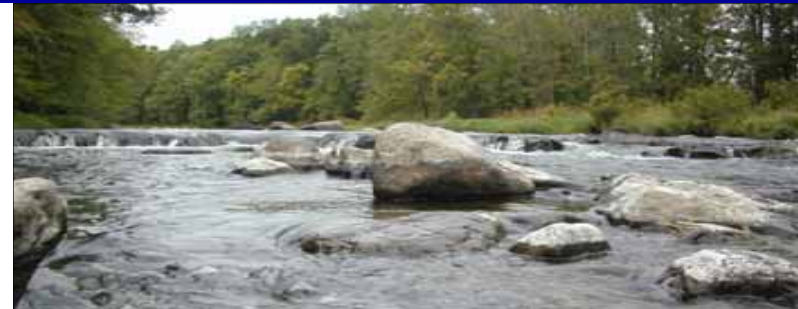
*Shawangunk Kill, station 21214, located at the end of Sax Rd. Shawangunk Ulster County NY.*

**Station 21214** in the Shawangunk Kill is located at the end of Sax Rd. The BAP score, 8.50, indicated non-impacted water quality. The macroinvertebrate community structure was diverse with 24 genera. ISD was most similar to a natural non-impacted community.
